PHASE I INSPECTION REPORT
NATIONAL DAM SAFETY PROGRAM

**BOX ELDER CREEK DAM
PLENTYWOOD, MONTANA
SHERIDAN COUNTY
MT-934**

PREPARED BY:
CH2M HILL
BELLEVUE, WASHINGTON
DECEMBER 1980

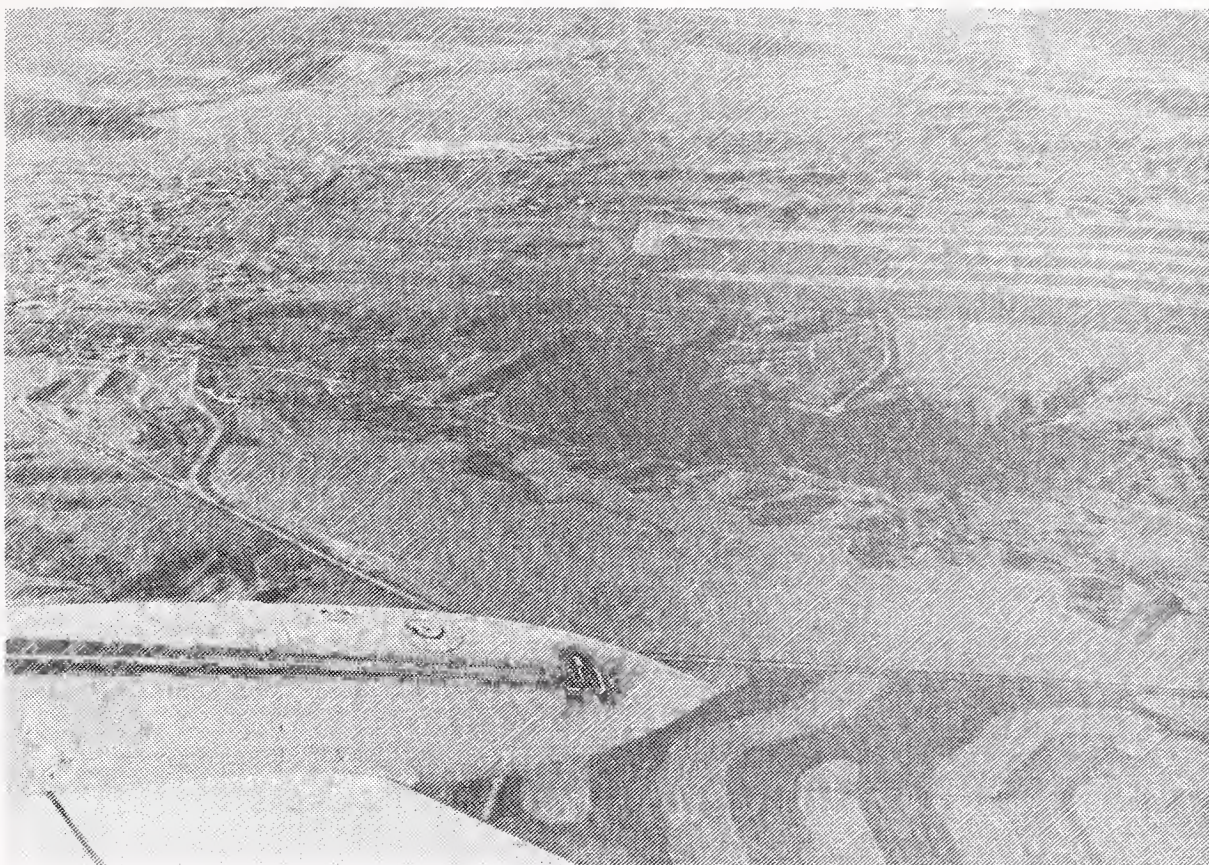
(PHOTO 1) DAM AND RESERVOIR

Box Elder Creek Dam is located on Box Elder Creek, a tributary of Big Muddy Creek about 52 miles upstream of its confluence with the Missouri River. The damsite is approximately 0.3 miles north of Plentywood (Photo 1), in Sheridan County, Montana (see Plate 1). The dam provides flood protection for the city of Plentywood. The dam is listed as having a high (Category 1) downstream hazard potential. The Federal identification number is MT-934. The dam is 60 feet high and approximately 1,800 feet long and impounds 6,620 acre-feet at dam crest, elevation 2121.1 feet NGVD. The dam was constructed in 1963.

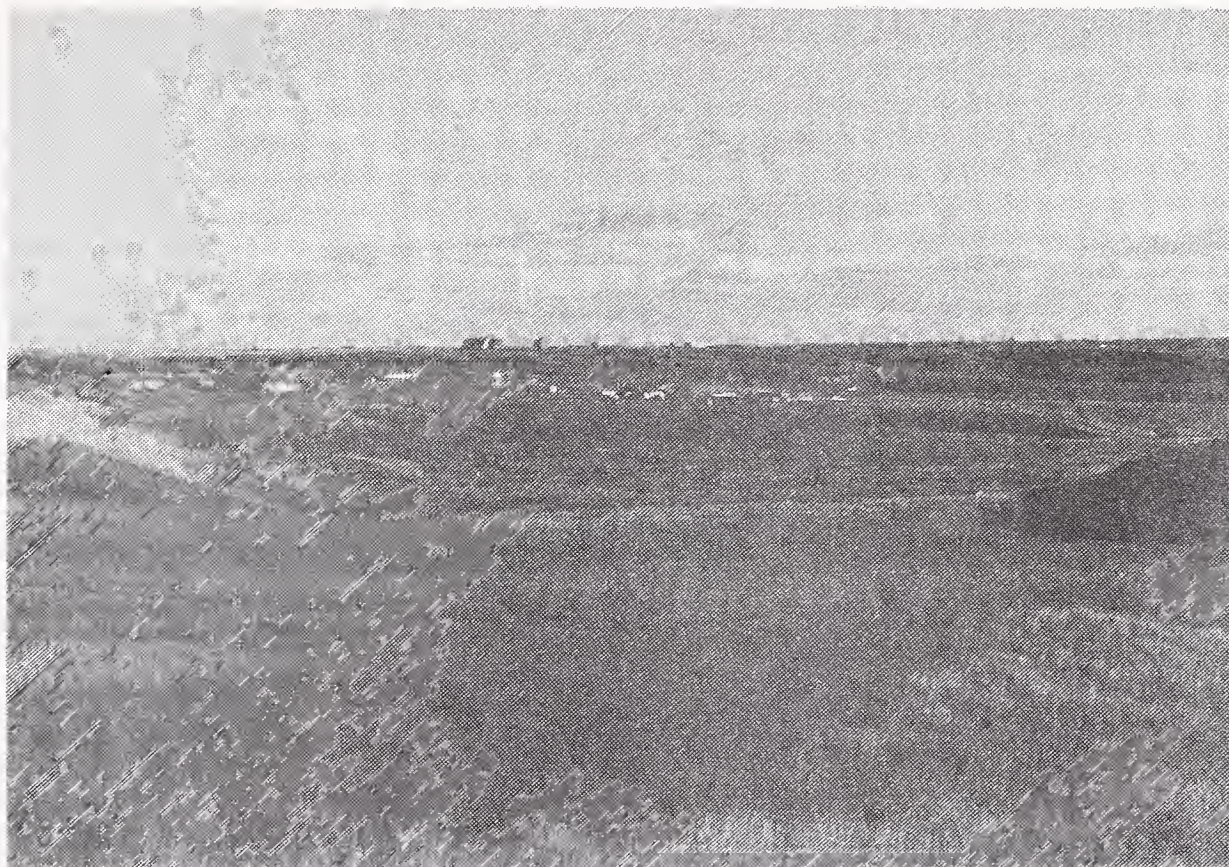
(PHOTO 3) WEST EMERGENCY SPILLWAY - LOOKING DOWNSTREAM

expected to occur to buildings along Box Elder Creek in Plentywood if the emergency spillway was operated. Operation of the west emergency spillway channel would also cause erosion of the dam embankment (see Plate 6.)

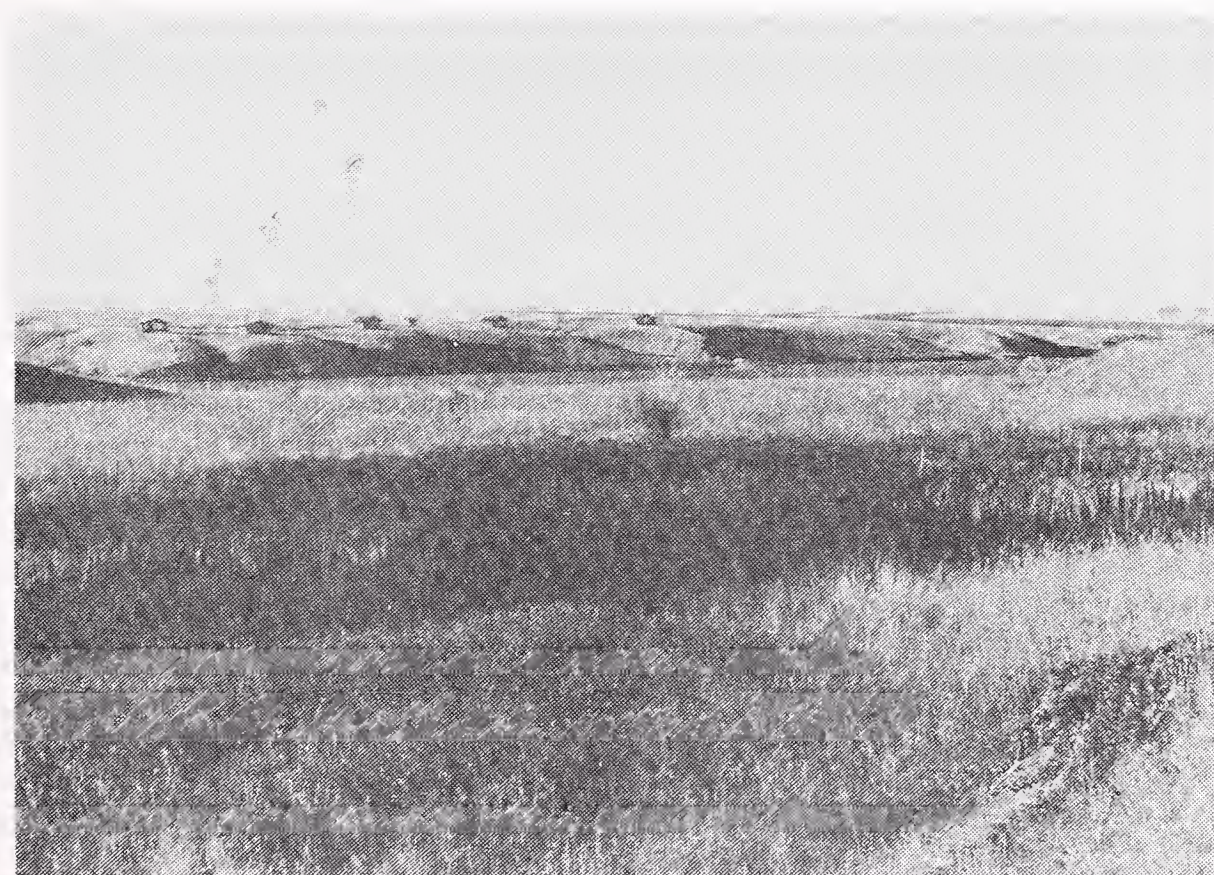
(PHOTO 4) EAST EMERGENCY SPILLWAY - LOOKING UPSTREAM

The east emergency spillway has no energy dissipator and discharges to a natural gully that reenters the Box Elder Creek channel about 1,000 feet downstream from the toe of the dam. The spillway is in very good condition but has never operated. Several structures are located in the discharge channel (natural gully) and would be damaged or destroyed by spillway releases. The Box Elder Creek channel has inadequate capacity downstream of the dam to carry discharge from the emergency spillway. Additional structural damage would occur to buildings along Box Elder Creek in Plentywood if the emergency spillway operated.

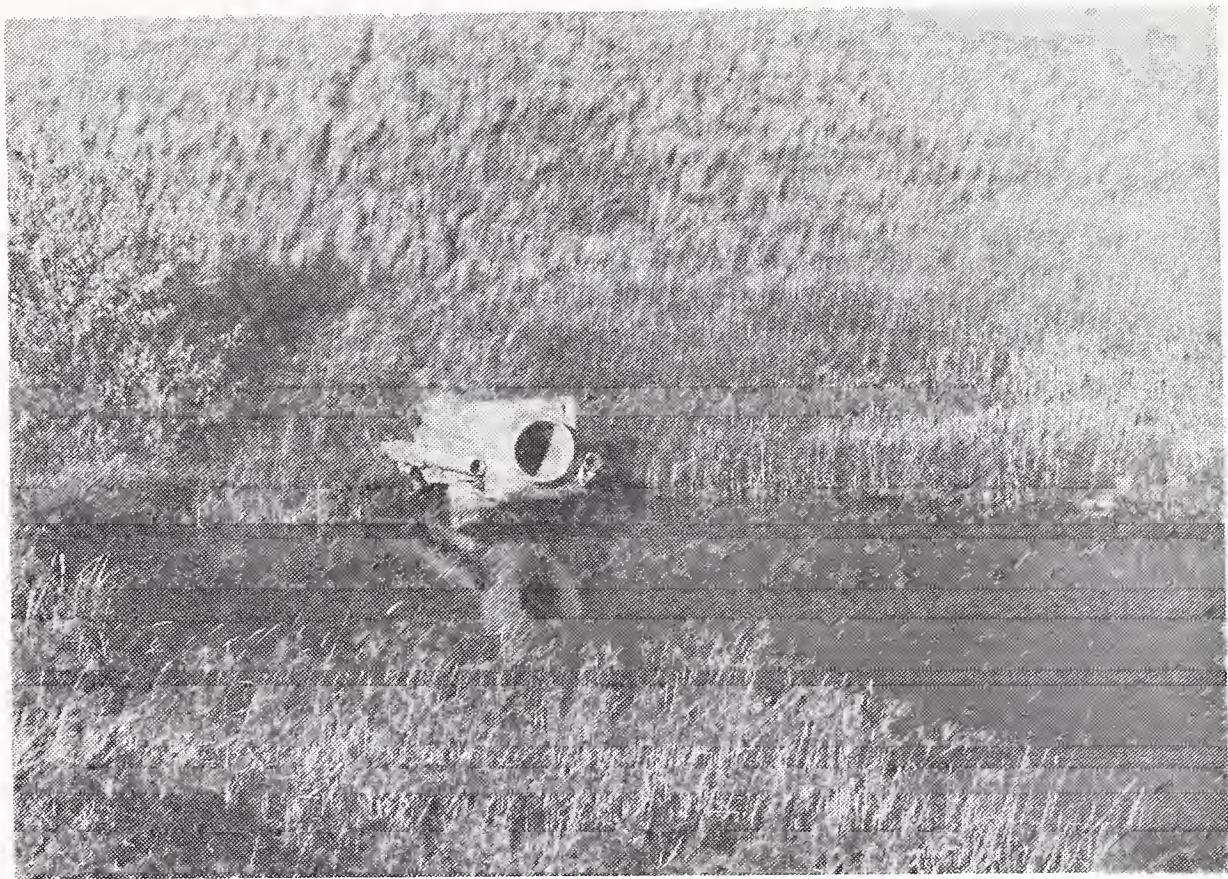
(PHOTO 7) OUTLET WORKS PIPE AND EMBANKMENT DRAINS

During the inspection, the drain pipes were dry and Mr. Abenroth, SCS representative, mentioned that no flow from the drain had ever been observed. No seepage or erosion from past seepage was observed on the embankment or abutment contacts. Some wet areas were noticed approximately 50 feet downstream from the embankment toe near the left (east) abutment. Seepage was flowing into the old stream channel about 100 feet from the embankment toe downstream of the road (shown in Photo 8). No serious erosion has occurred. The pool elevation during the inspection was 2087.7 feet, 33.4 feet below the top of the dam.

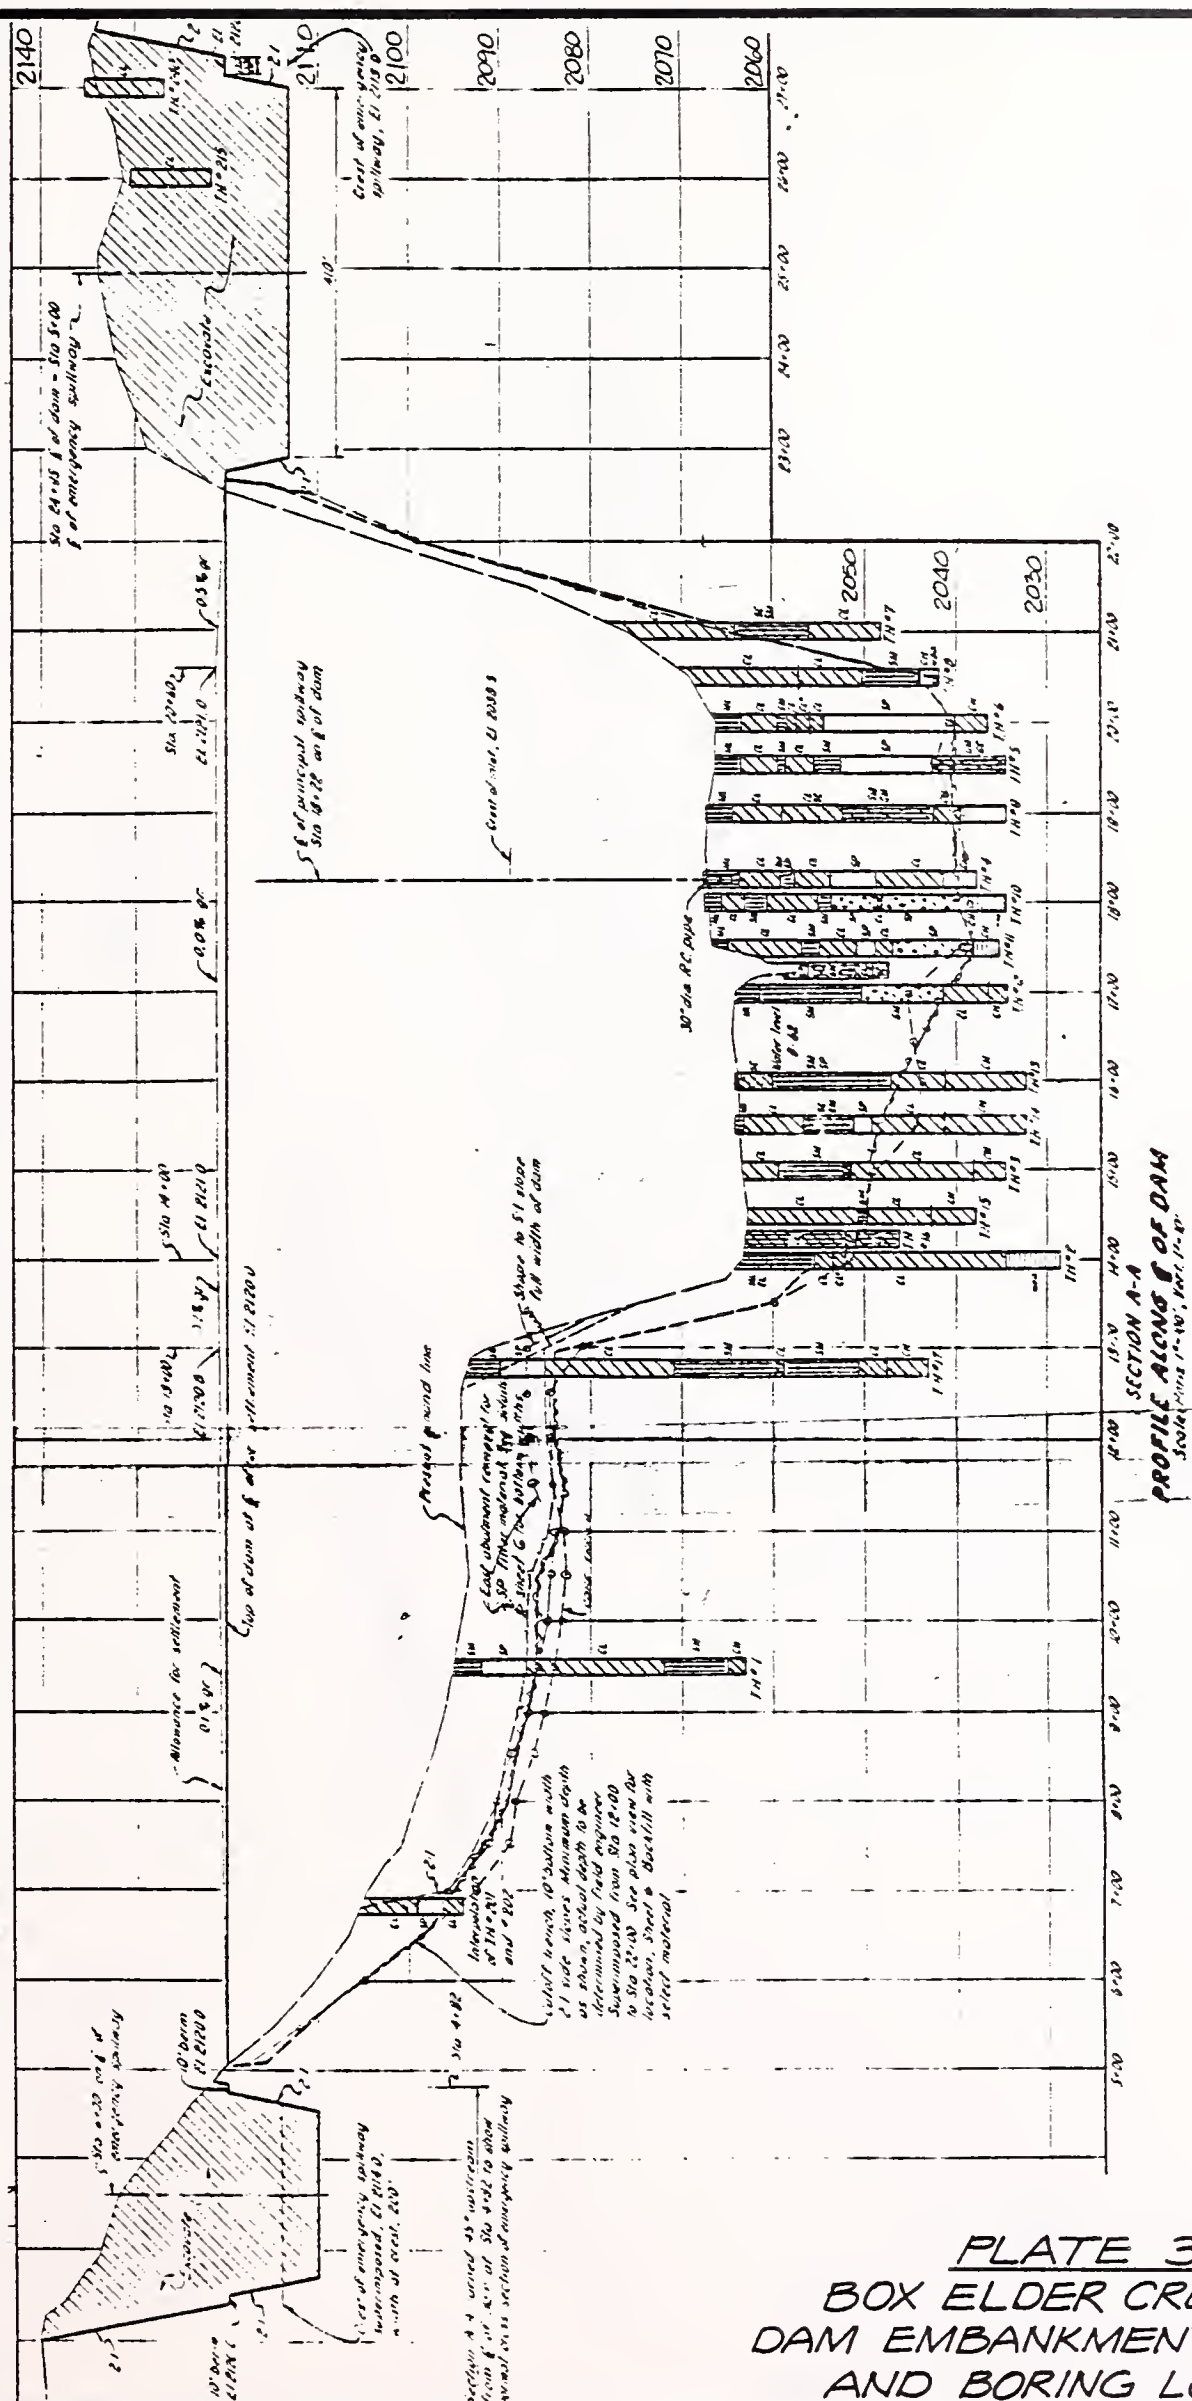
PLATE 3
BOX ELDER CREEK DAM
DAM EMBANKMENT PROFILE
AND BORING LOGS

Box Elder Creek Dam is constructed on alluvial flood-plain sediments. Preconstruction boreholes (Plate 3), drilled beneath the embankment, indicate the flood-plain sediments to be about 30 feet thick overlying clay shale bedrock. On the flood plain from the channel of Box Elder Creek to the west abutment, borings encountered lean to fat, slightly organic clay to a depth of approximately 30 feet. Below this depth, clay shale bedrock was encountered. Bedrock consists of stiff to hard, moist, moderately plastic clay shale. Borings in the flood plain from the channel of Box Elder Creek to the east abutment encountered a natural blanket of silty and sandy clay approximately 3 feet thick, underlain by moderately permeable sand, silty sand, silty gravel, and sandy gravel. Clay shale bedrock was encountered approximately 30 feet below the surface of elevation 2,035.7 feet.

Both abutments consist of glacial till, channel outwash, and terrace gravel overlying stratified sediments of fine silt, sand, and low to highly plastic clay (see section 1.2.3). The foundation materials, as shown on Plate 3, are various layers of silt, clay, and sand for the top 30 to 40 feet, underlain by clay and weathered clay shale. As-built drawings (Plate 10) show that a cutoff trench upstream of dam axis was carried up to 30 feet deep, with side slopes of 1 V on 2 H and a bottom width of 10 feet. Backfill material and method of placement are unknown. The boring logs on Plate 3

indicate that the cutoff trench extended into the clay and clay shale along most of the dam foundation; however, at the east abutment, borings No. 1 and No. 17 show that silty sand layers 10 to 20 feet thick and 15 feet below the cutoff, were left intact beneath the cutoff.
